The First United States Army Aircraft Accident Report

(September 1908)

**War Department
Office of The Chief Signal Officer,
Washington Aeronautical Division**

I have the honor to submit the following detailed report of the accident to the Wright Aeroplane at Ft. Myer, Virginia, on September 17, 1908.

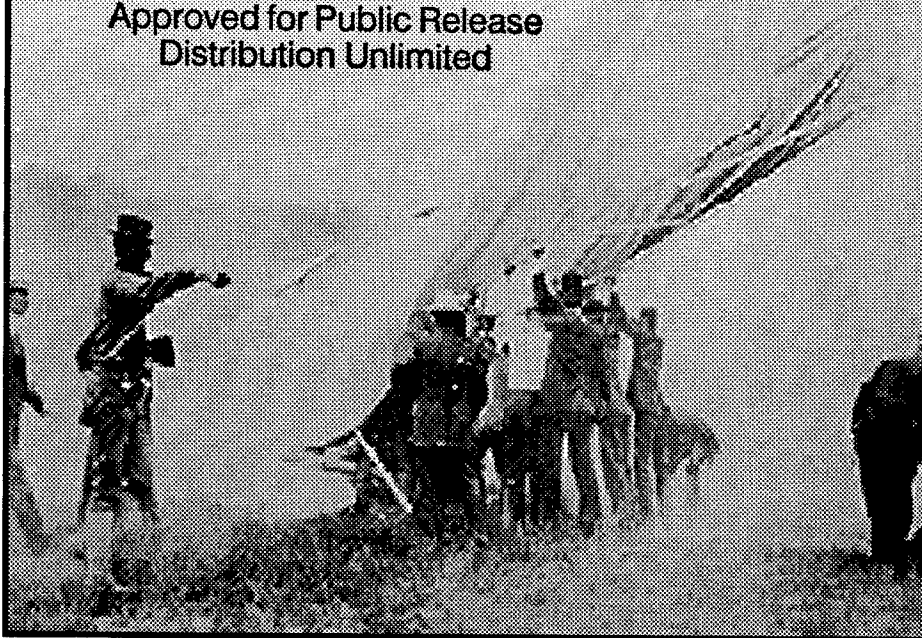
The first U.S. Military aviation mishap involving powered flight occurred before the Army even owned an airplane. The crash was at Fort Myers, Virginia, on 17 September 1908. The occasion was the final flight in the acceptance trials of the first aircraft purchased from the Wright brothers.

Lieutenant Thomas E. Selfridge was flying with Orville Wright. After they had been airborne about 3 or 4 minutes, the aircraft suddenly nosed over and crashed at a steep angle. Lt Selfridge was fatally injured and died several hours later. Orville was seriously injured and hospitalized for 7 weeks.

The Army ordered an investigation to learn the cause of the mishap. The investigation consisted of observing the remains of the crashed aircraft and taking witness statements. The board found a new, longer propeller contacted a rudder guy wire and eventually caused the wire to come out of its socket. This allowed the rudder to fold sideways, and the pilot lost control.

And it worked. The Wright brothers designed an improved version of their aircraft with structural changes which ensured the propellers could not hit any guy wires. This marked the beginning of the flight safety program so familiar to us today.
